Assessment of Ecosystem Services and Disservices in Urban Environment Using Multispectral Image Analysis and Geospatial Mapping

Md. Nazmul Haque^{*1}, Irtija Alam², and Atif Aninda Rahman³

Department of Urban and Regional Planning, Khulna University of Engineering & Technology, Khulna-9203, Bangladesh

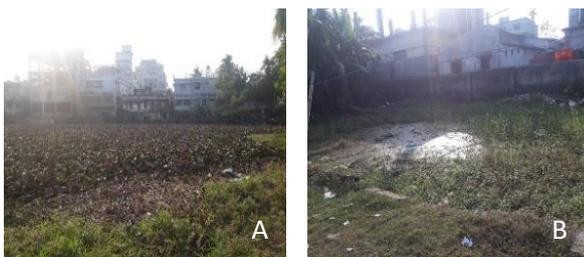
Figure 9: Water quality degradation on two areas A and B of the existing area

Sediment export on some water bodies resulted from land filling, silt comes from water runoff and nearby contractions reduce the depth of the water body, toxic chemical contamination and degrades the water quality which is unhealthy for the aquaculture in some cases and posed threat to the ecosystem in the water body. Different types of water hyacinths, darnel species and waste in the surface of the water body (Location: 763928.16mE, 2524686.99 mN Figure 9(A) and 764065.21mE, 2524692.17 mN Figure 9(B) also degrades the water quality which can destroy the function of the water body and the ecosystem in it.
